The Public Inquiry into the Piper Alpha Disaster

The Hon Lord Cullen

VOLUME ONE

Presented to Parliament
by the Secretary of State for Energy
by Command of Her Majesty
November 1990

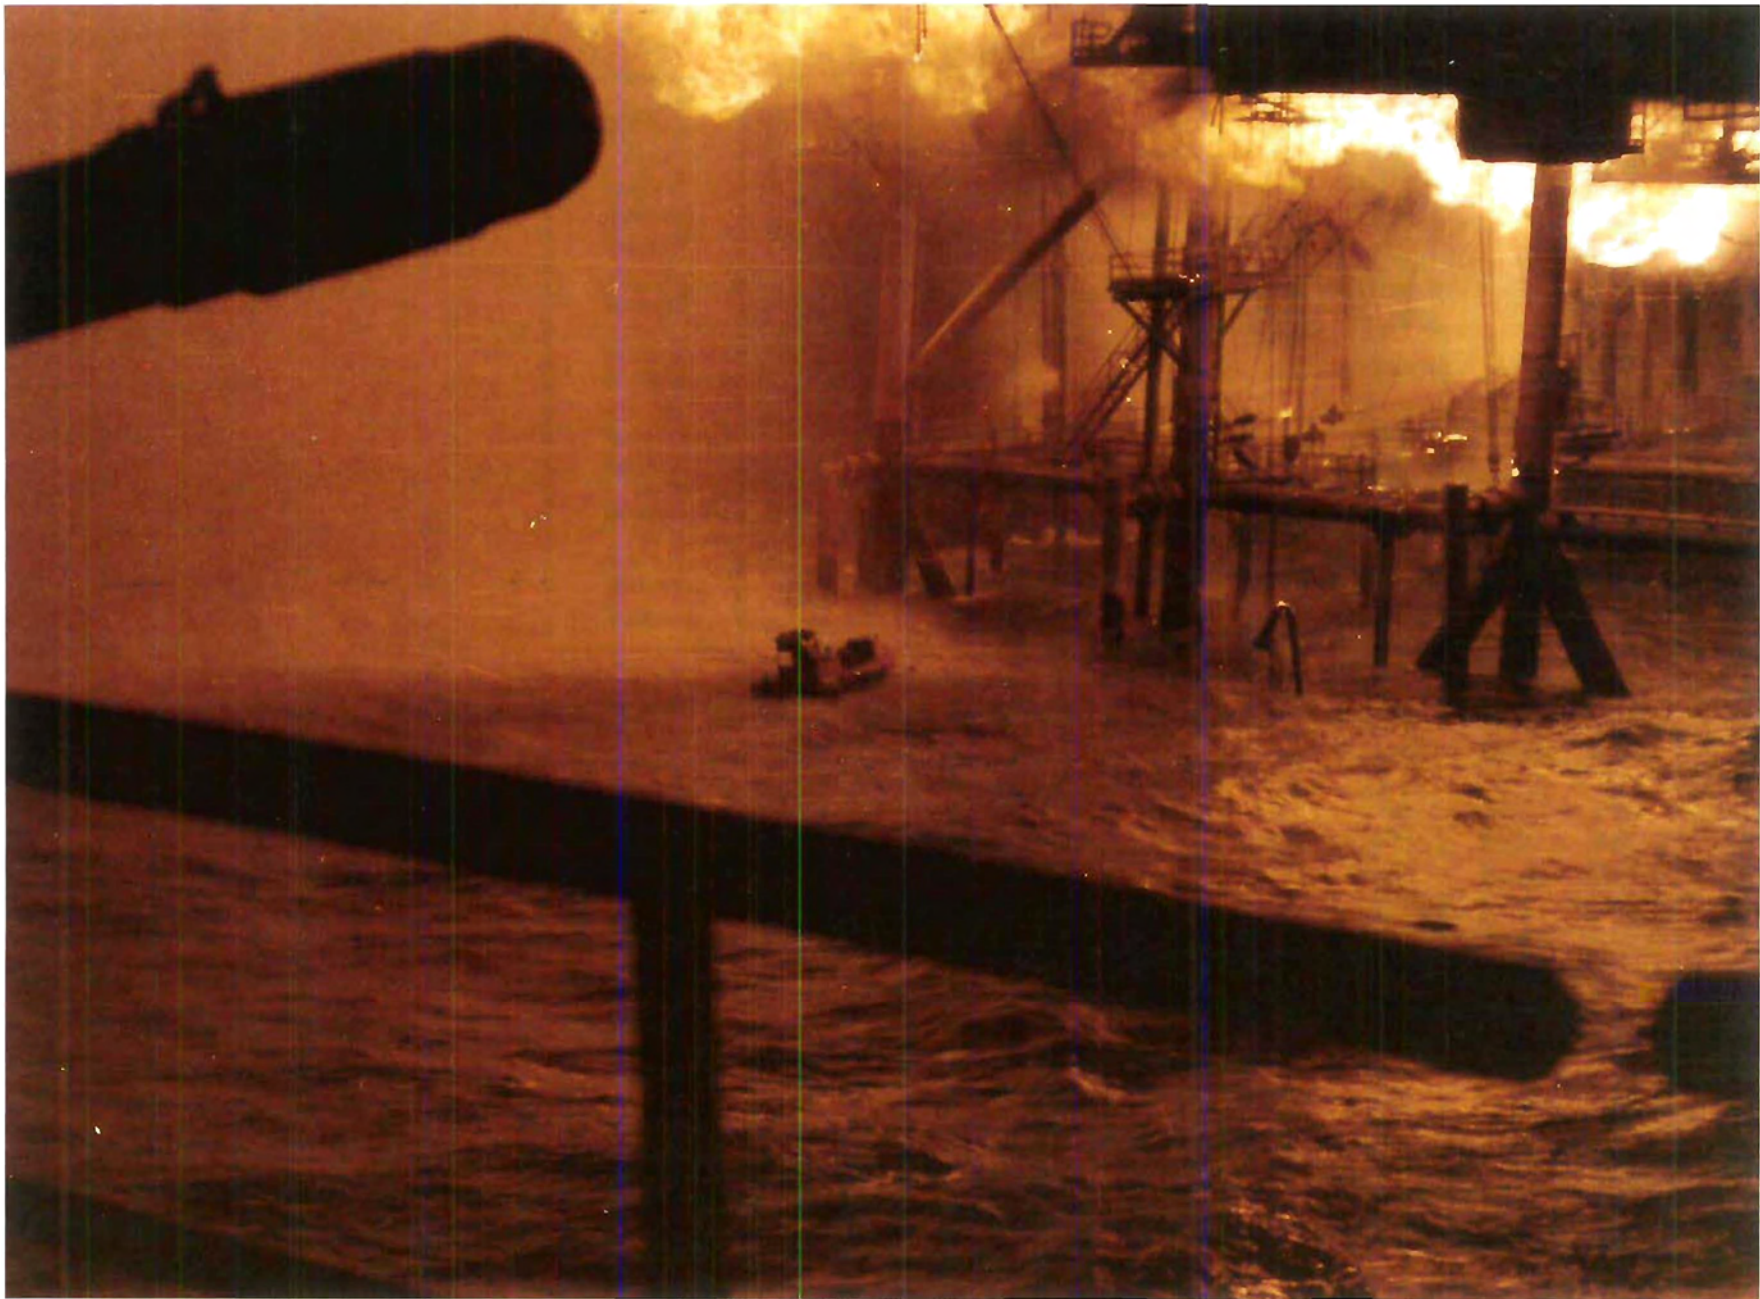
Frontispiece

A fast rescue craft near the 20ft level some time after the first riser rupture: photograph taken by Mr Miller from the *Tharos*.

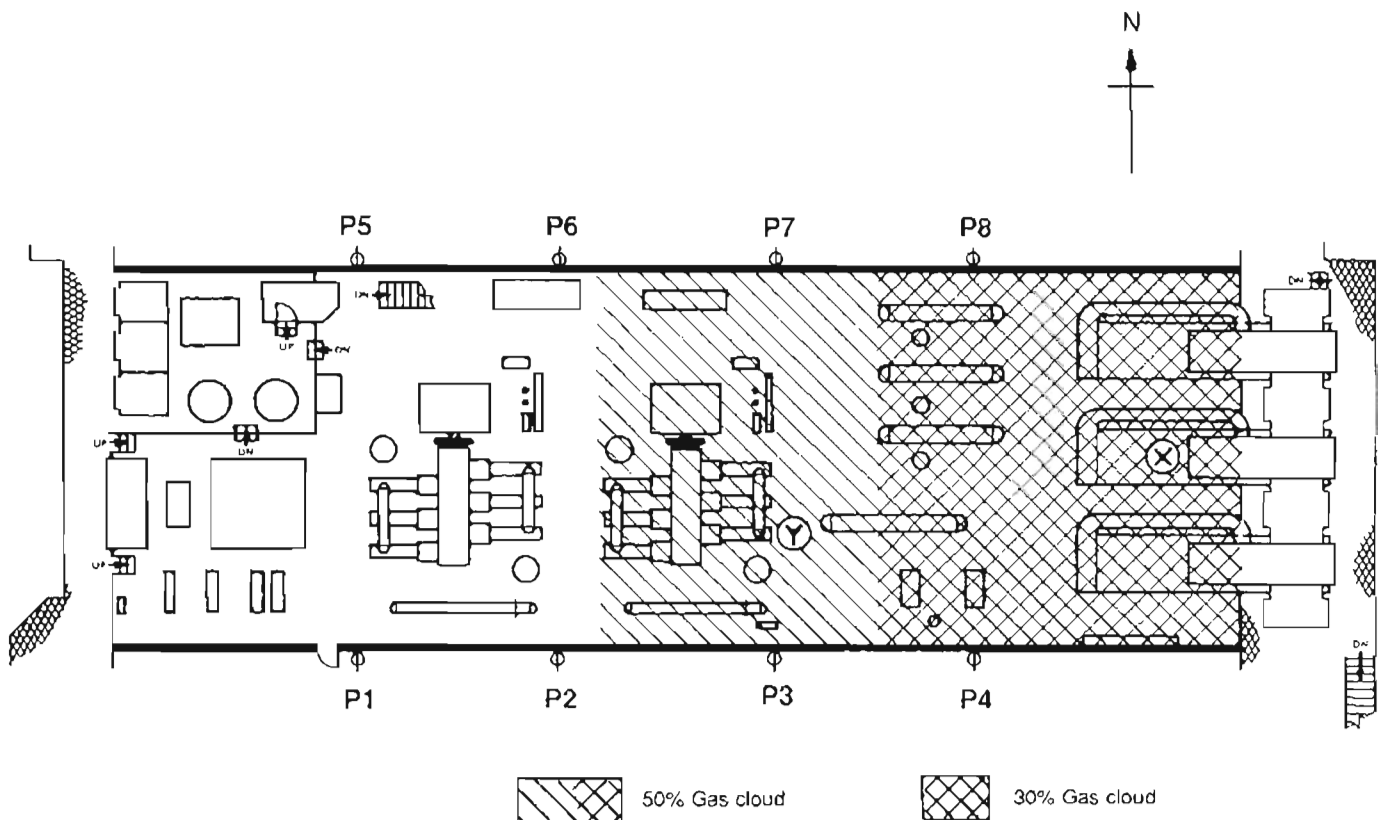
5.88 Shortly after the Piper disaster CMI was commissioned by the DEN to perform simulations using the FLACS code for a number of scenarios of explosions in C Module. The report on this work was spoken to by Dr Bakke. The layout of C Module entered into the code is shown in Fig 5.1. The figure also shows the 8 points, P1-P8, at which the pressures were measured and the locations X and Y of the ignition sources. 5 cases were considered. Cases 1, 2 and 4 involved natural gas and cases 3 and 5 condensate. The module fill was 50%, in each case, except for case 4, for which it was 30%. Wall failure was allowed for in all cases except case 5. For cases 1 and 4 the location of the ignition source was at the eastern end of the cloud, for cases 2, 3 and 5 at the centre of the module. The details of and results for these cases 1-5 studied by CMI for the DEN are given in Table 5.1 as runs 1-5. This work showed that there are a number of scenarios which would lead to pressures high enough to cause failure of the firewalls. It also illustrated a number of important trends. It showed that higher over-pressures are generated if the hydrocarbon cloud is larger, if there is no failure of the firewalls, if the ignition source is at the centre and if the fuel is condensate rather than natural gas. Further details of the work are given in Appendix G.

Fig. 5.1 Plan view of C Module, showing pressure points P1-P8, 30%, and 50% fill gas clouds and ignition sources X and Y used in the CMI explosion simulations.

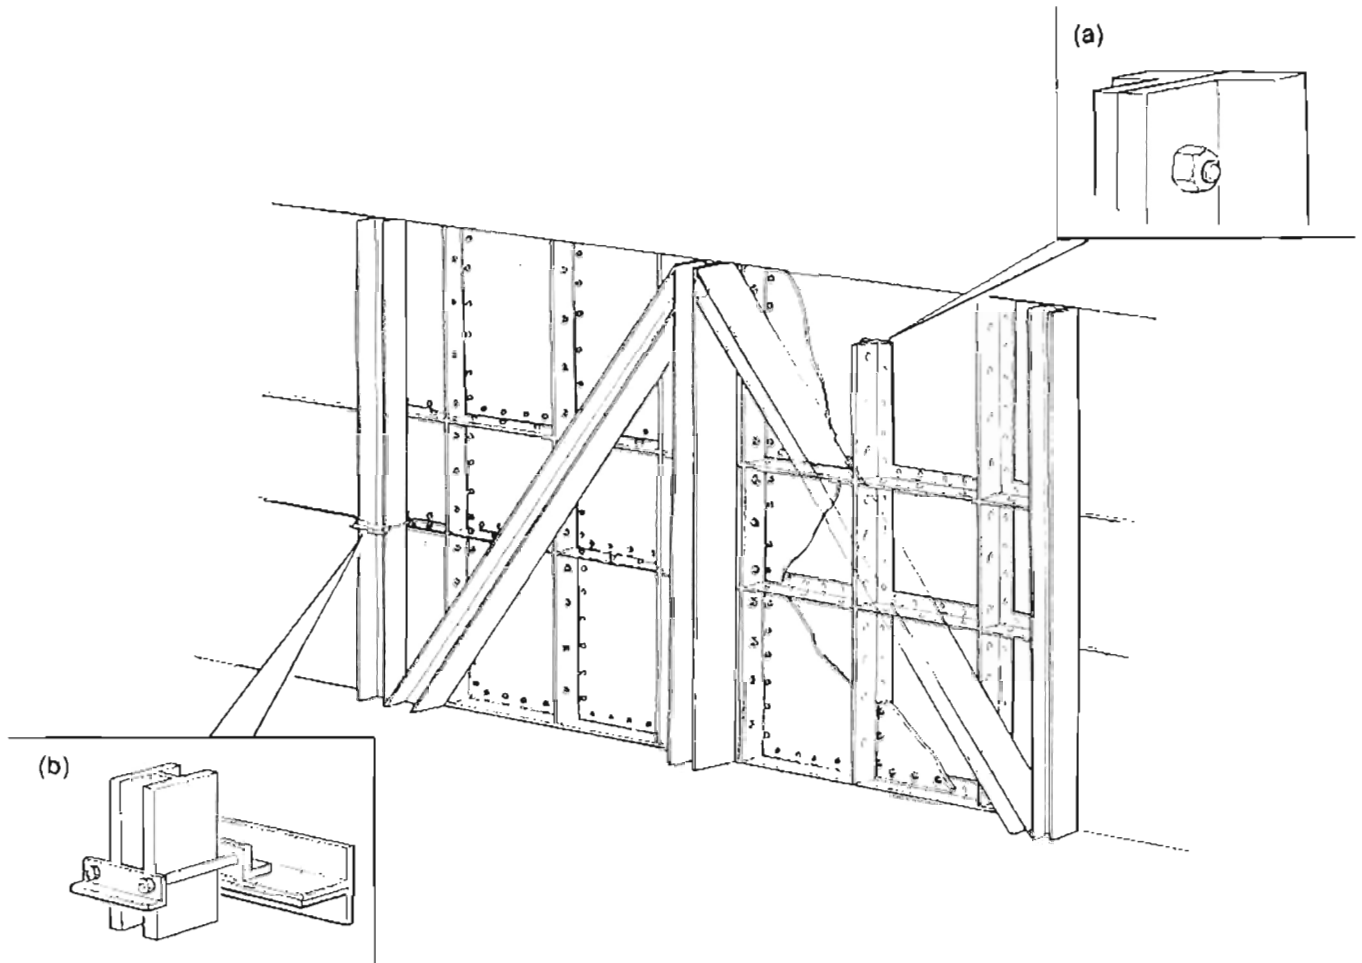
5.100 The B/C firewall was a single-layer 4.5 hour integrity wall. It consisted of an array of rectangular panels, bolted into rectangular frames, with adjacent frames bolted together, forming a 'lattice'. The lower edge of the wall was welded to the production deck and its top edge attached to the underside of the upper truss beam by an arrangement of bolted and welded joints. The wall was further supported by clamping to the truss columns. The firewall is illustrated in Fig 5.2; the figure is schematic and is not to a consistent scale. The view seen in the figure is that seen from the inside of C Module looking south. In the analysis of failure of the single-layer firewall the following failure modes were considered: panels, panel bolts, lattice framework, frame bolts, clamps and welds to the deck and to the truss. Dr Cox summarised the analysis as follows. The capacities of both panel and frame bolts would be exceeded at a pressure of about 0.1 barg. Of the 2, the frame bolts were more critical in that failure of these would lead to failure of the lattice. Failure of the clamps would occur at about 0.12 barg and of the panels themselves at about 0.15 barg. In effect, the firewall would disintegrate at over-pressures somewhere in the region of 0.1-0.15 barg. He took the effective failure pressure of the single-layer firewall as 0.1 barg. The behaviour of the single-layer firewall in failure would be as follows. At pressures below about 0.1 barg the panels would start to deflect; at about this pressure frame and panel bolts would start to fail; at pressures above it frames would start to separate and, where the lattice was still intact, panels would start to collapse, whilst the clamps holding the whole wall might start to fail.

Fig. 5.2 Schematic of single-layer firewall between B and C Modules: insert (a) frame bolt; insert (b) clamps.

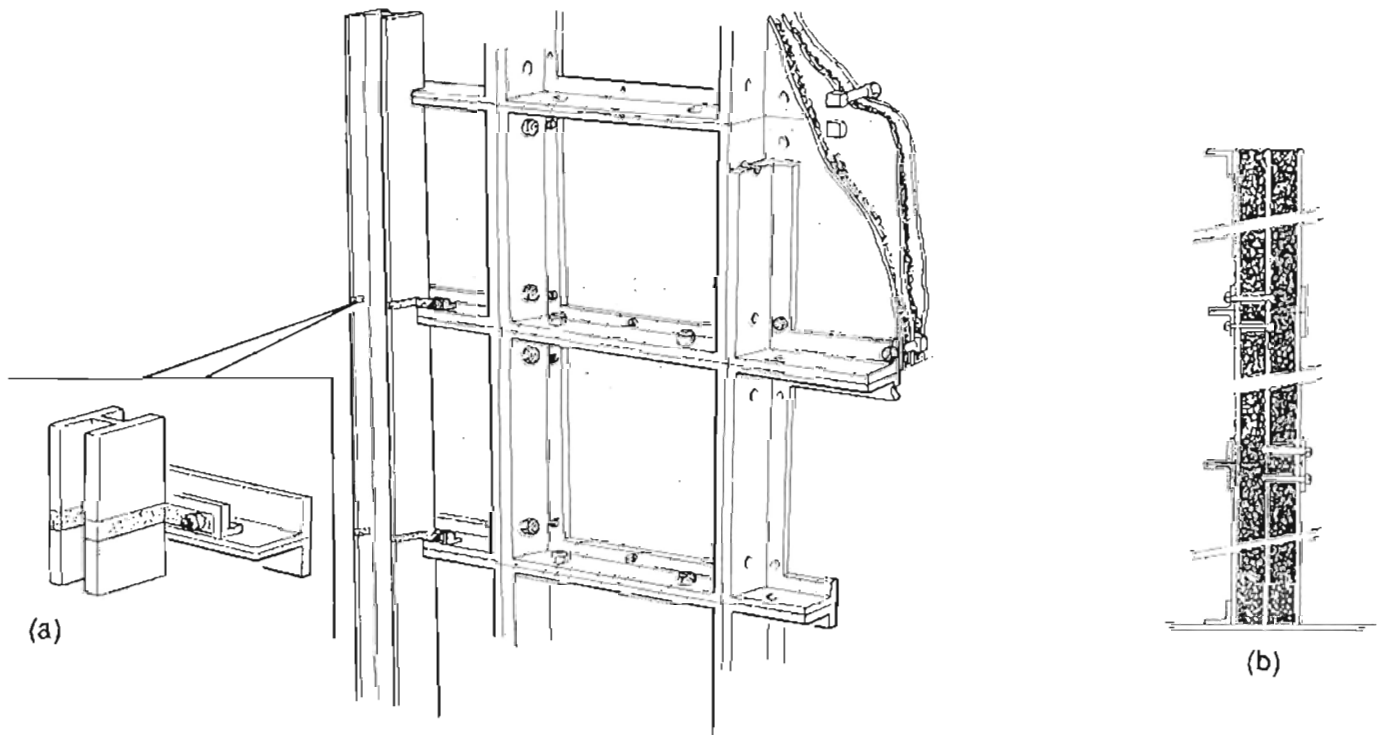
5.101 The C/D firewall was a triple-layer 6 hour integrity wall. This wall also differed from the single-layer wall in that the panels were of different size; the frames were smaller, being 7 rather than 3 frames high; there was a complex offset bolting arrangement; the arrangement of the panel and frame bolts was different in detail; and the clamping arrangements were different. The firewall is illustrated in Fig 5.3; the figure is again schematic but in this case the panelling is on the remote side of the lattice. The view in the figure is that seen from the inside of D Module looking south. An analysis similar to that on the single-layer firewall was performed on the triple-layer firewall. Again the frame bolts were the weakest component. Failure of these bolts was predicted to occur at a pressure of 0.12 barg. Failure of the panel bolts in

Fig. 5.3 Schematic of triple-layer firewall between C and D Modules: insert (a) clamps; insert (b) cross-section through fire wall, showing three sheets with mineral wool between.

shear loading or tearing of the panel would occur at about the same pressure. The outer sheet of the panels, supported only by very narrow bolts, would also start to fail at about 0.12 barg. However, the inner sheet, being more strongly supported, would not fail until a pressure of about 0.36 barg. This is a higher pressure than the failure pressure of the panels of the single-layer firewall because the panels of the latter are larger. Dr Cox took the effective failure pressure of the triple-layer firewall as 0.12 barg. As far as concerns the failure behaviour of the triple-layer firewall, at pressures below about 0.12 barg the panels would start to deflect; at about this pressure frame and panel bolts would start to fail and panels to tear; at pressures above it frames would start to separate and panels to separate from the frames but not to push through until higher pressures are reached.

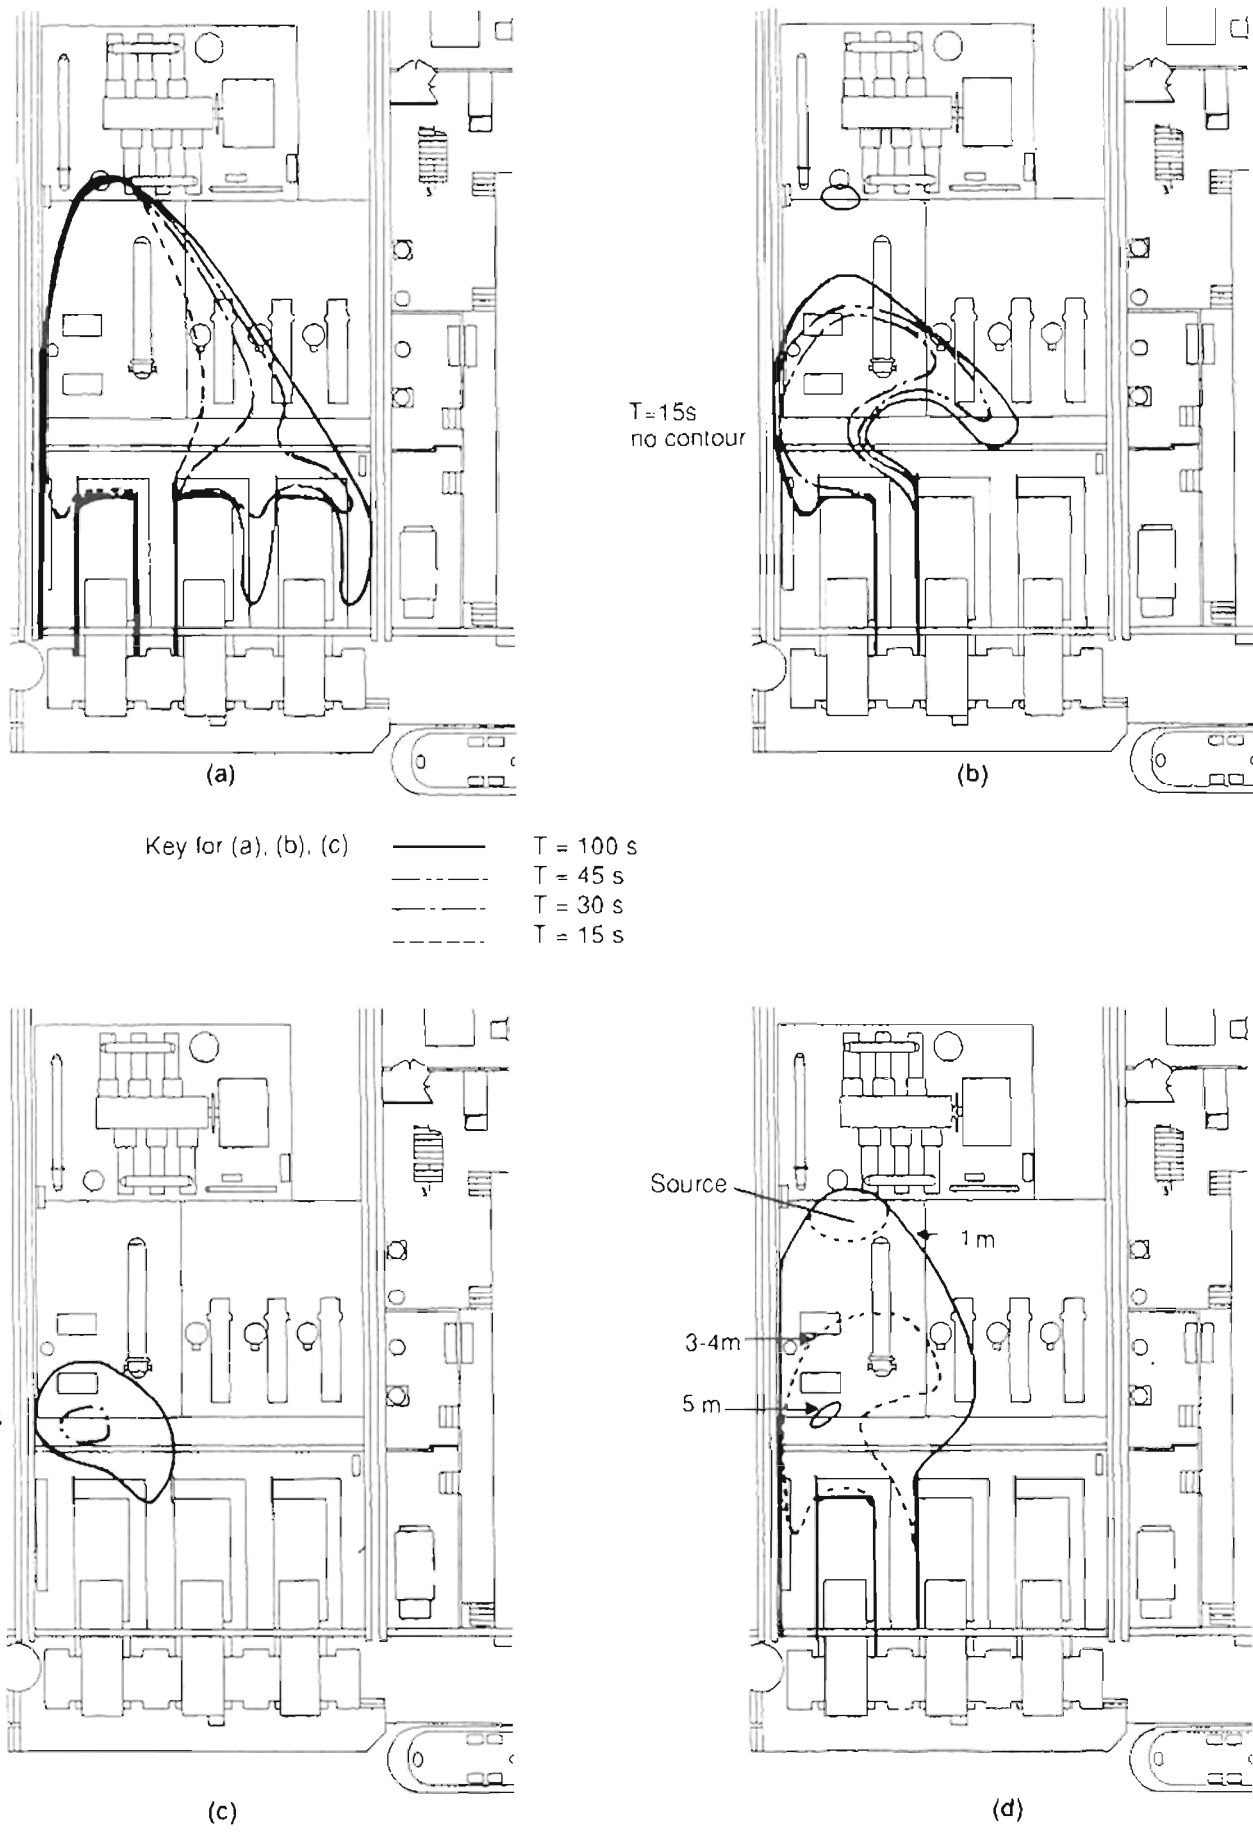
6.34 The tests point to the later, larger leak as being one of propane from position 1, from a downward pointing jet or partial fan. The 2 sets of test results given taken

Fig. 6.1 Growth of the flammable gas cloud for leak of 100 kg/min (Series 42) in the BMT wind tunnel tests: (a) LEL contours at low level ($< 1.7\text{m}$); (b) LEL contours at intermediate level (ca. 3.5m); (c) LEL contours at high level (ca. 5.5m); and (d) LEL contours at 30 seconds.

together show that the C3 low level alarm came up first only in tests with these features. Tests involving a leak of neutrally buoyant gas in any of the 4 leak positions gave the C2 rather than the C3 low level alarm first. Moreover, these tests tended to give a much smaller gas cloud, which again tells heavily against them; the exception was the release of neutrally buoyant gas from the horizontal pipe at position 1, for which the flammable cloud was larger.

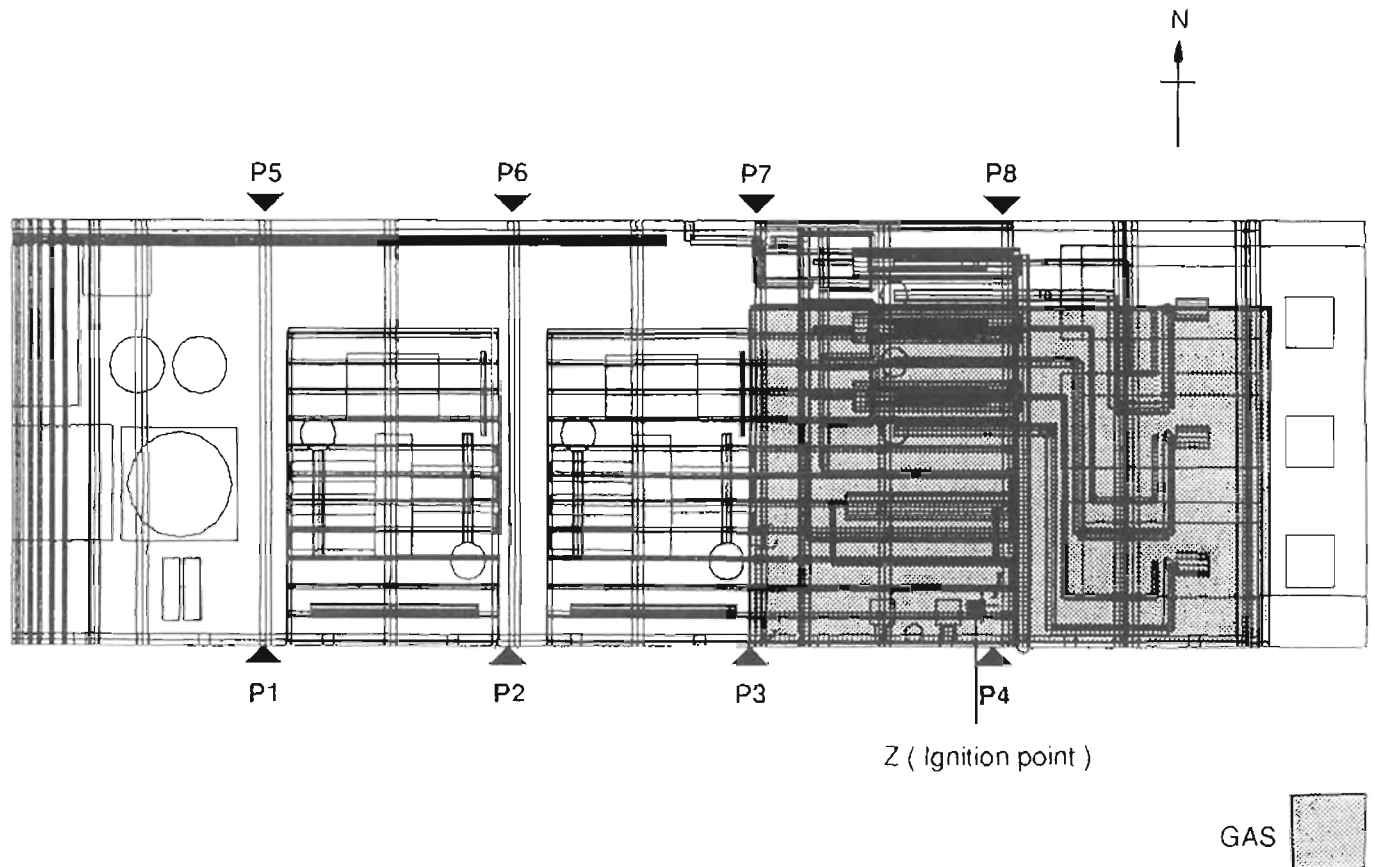
are shown in Figs 6.4 and 6.5. The firewall failure pressures used were revised values based on the evidence of Dr Cox, namely for the B/C firewall 0.10 bar and for the C/D firewall 0.12 bar. Wall porosities used were again for the B/C firewall 20%, and for the C/D firewall 40%. The results obtained are shown in Table 6.2 as case 6. For comparison the table also shows as cases 1-5 the results of the earlier runs for the DEn.

Fig. 6.4 Plan view of C Module showing pressure points P1-P8, 12% fill gas cloud and ignition source Z used in the final CMI explosion simulation.

6.40 The simulation for case 6 showed that the B/C and C/D firewalls would fail along most of their length. However, although the pressures experienced at point 5 are sufficient to cause failure of the north wall at that point, the pressure plots indicated that there was a short section at the west end of that wall which did not see pressures high enough to cause failure. The mass of fuel in the flammable gas cloud in the case 6 simulation was judged by Dr Bakke to be close to the lower limit for a cloud capable of causing substantial failure of the firewalls.

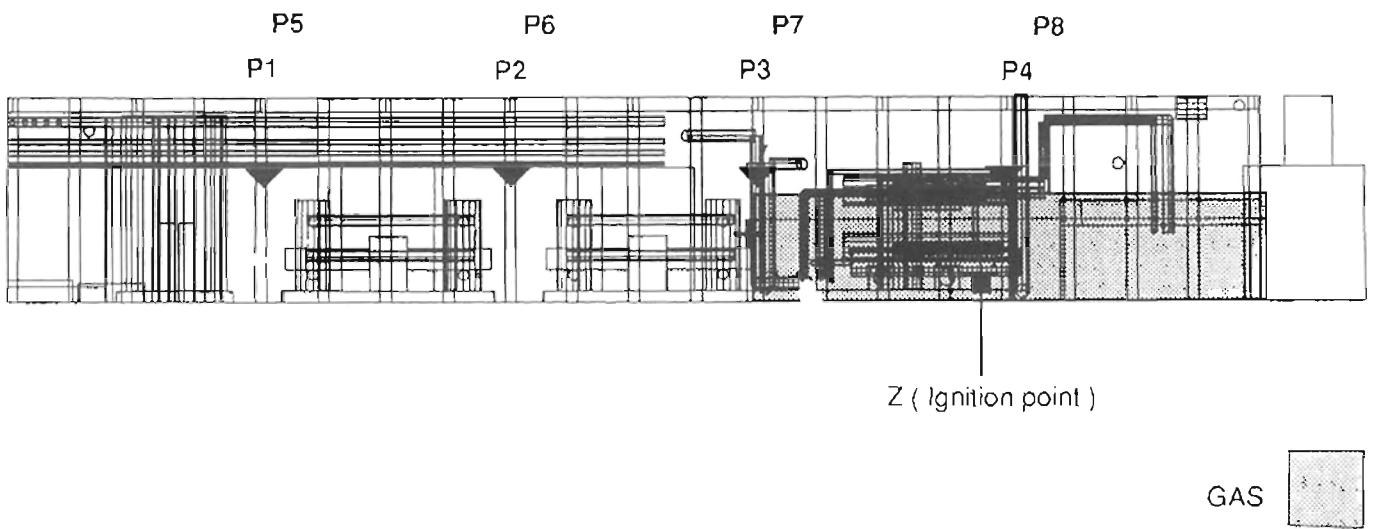
Fig. 6.5 Elevation view of C Module looking north, showing pressure points P1-P8, 12% fill gas cloud and ignition source Z used in the final CMI explosion simulation.

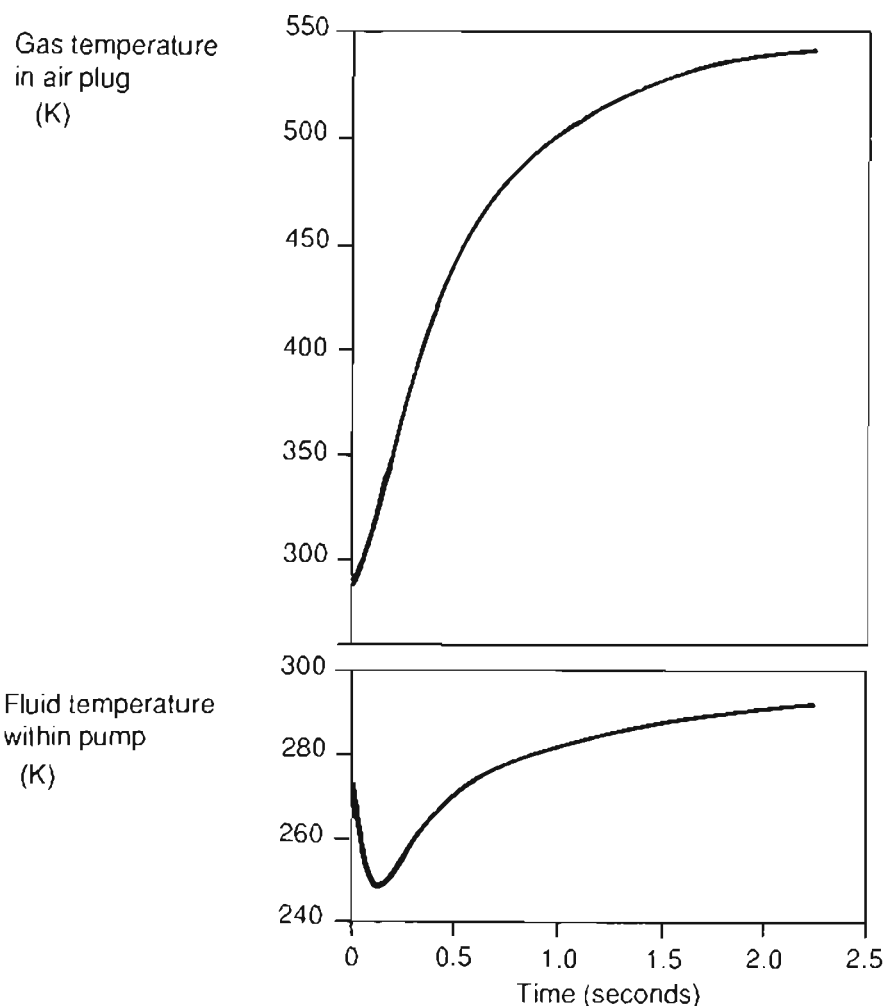
6.133 If a flammable mixture had accumulated in the relief line from the pump, sudden admission of condensate would cause compression of this mixture and could possibly result in ignition. Such autoignition would be similar to that which occurs in a diesel engine, where ignition is effected not by a spark plug but by compression, although the temperatures attained would be much lower. For ignition to occur, there would have to be a flammable mixture in the system. In other words, there would need to be ingress of air, which would depend on the extent of any openings to atmosphere. The evidence was that the flange at PSV 504 had been open for about an hour. There were also other possibilities. For example, if the valve used to vent the pump to flare had been left open, condensate vapour, being denser than air, would continue to stream out of this valve, drawing air in at the top through the flange at the site of PSV 504. It was not known how long the pump vent valve might have been open nor whether this coincided with the period when the flange was open. As far as

Fig. 6.6 Estimated temperatures of gas (air) and liquid on admission of condensate through GOV 5005 into condensate injection pump A system.

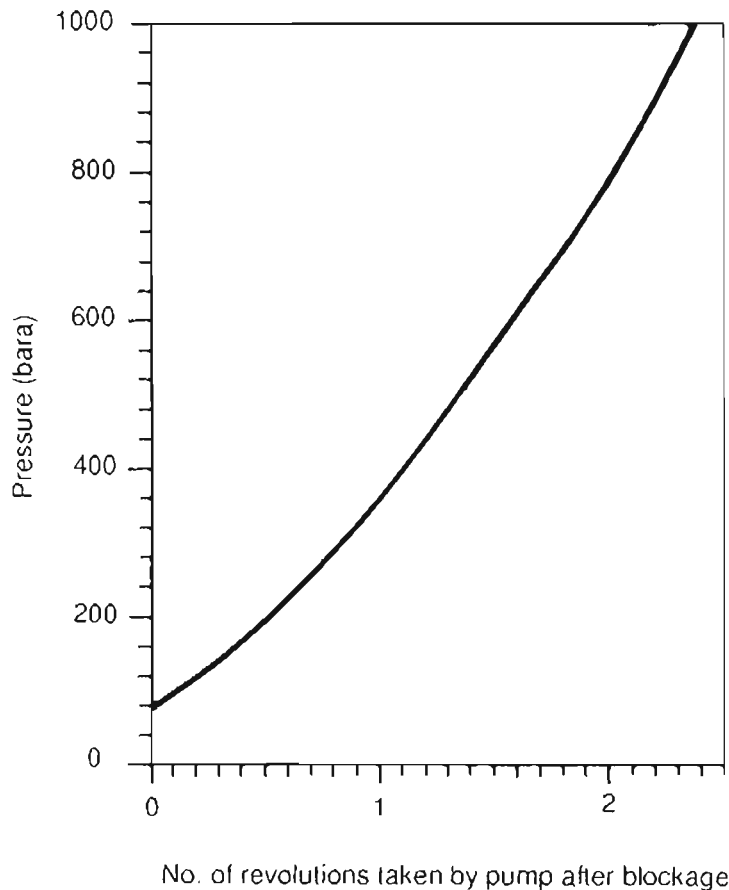
6.158 The pressures which might have been attained if pump over-run occurred were estimated in the ninth report by Drs Richardson and Saville, spoken to by Dr Saville. Fig 6.7 gives the pump discharge pressures as a function of the number of revolutions of the pump and shows that a pressure of 250 bar would have occurred after less than 1 revolution of the pump. At the normal pump speed of 100 rpm, this pressure would have been reached in about 0.6 seconds, or at the minimum speed of 40 rpm in 1.5 seconds. The pressures estimated assume that nothing happens to prevent such pressure rise. Dr Saville mentioned as points to consider whether the pump pistons or valves would withstand the pressures or the drive fracture. He agreed that it would also be necessary for the hydrate plug to hold, but stated that he had experience of plugs of particulate matter withstanding 2000 bar, albeit in different sized pipe.

Fig. 6.7 Estimated pressure rise in condensate injection pump B discharge pressure with no pressure relief.

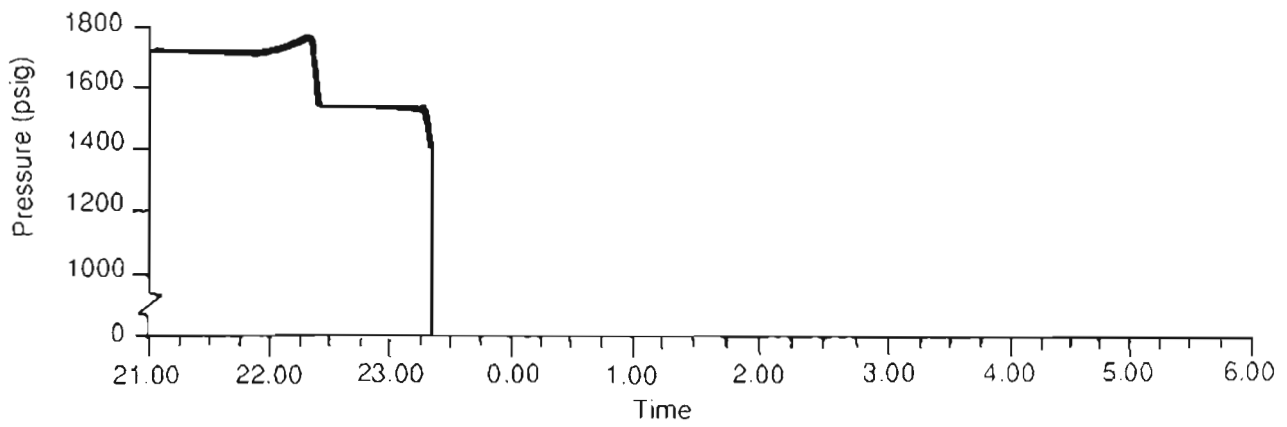
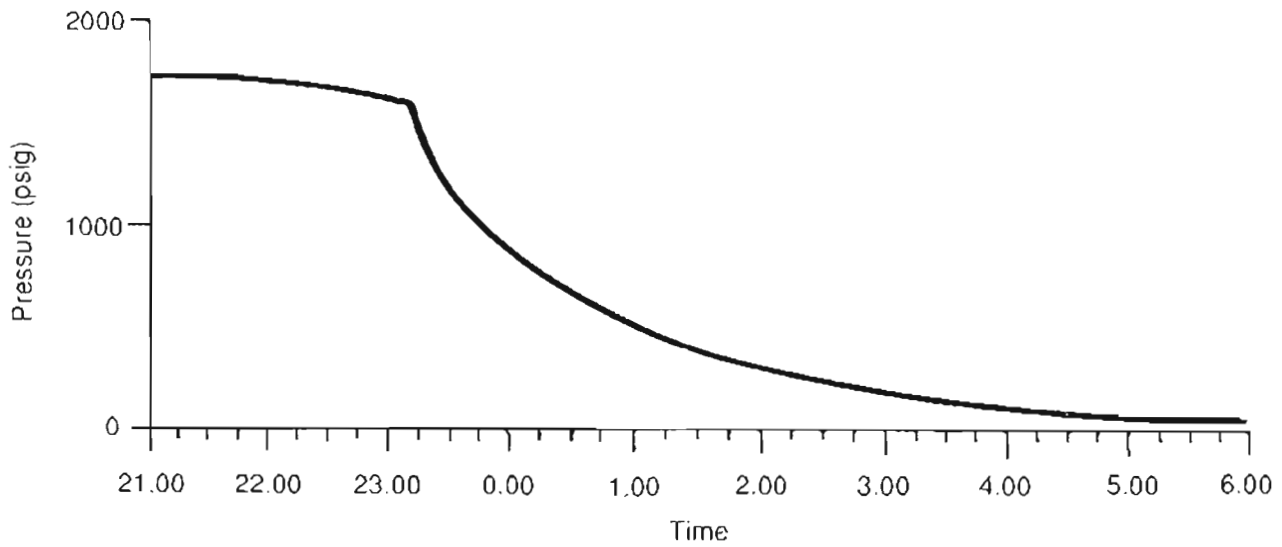
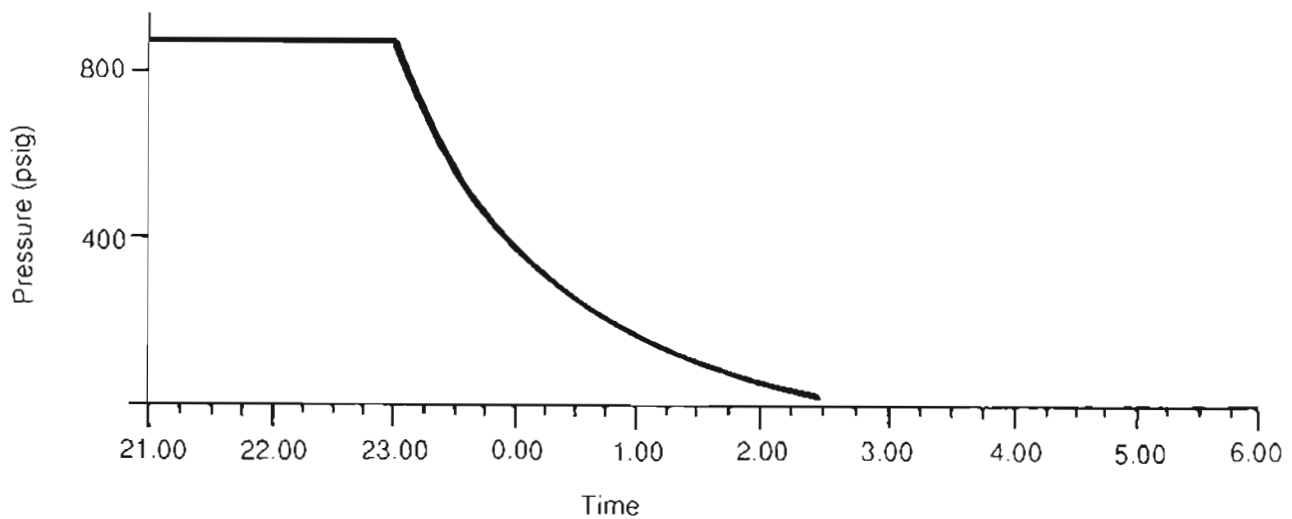
7.36 The depressurisation of the gas pipeline from Tartan to Piper was instructed on Tartan between 22.30 and 22.45 hours. This took until 23.20 hours to set up, the last step being the opening of the export gas valve ECV 54. As will be explained below, it was then found that the pipeline contained virtually no gas pressure which was capable of being measured at Tartan. The depressurisation of the gas pipeline from Piper to MCP-01 was carried out at MCP-01 starting just after 23.00 hours. This pipeline normally contained about 60 MMSCF. The flaring capacity at MCP-01 was 2.6 MMSCFD. The depressurisation of the gas pipeline between Piper and Claymore was instructed on Claymore about 23.00 hours and took about 5 minutes to set up. Depressurisation was carried out through FCV 970. In addition after 24.00 hours gas was taken through the separators to the low pressure flare. It is uncertain how quickly this pipeline lost pressure. According to Mr J Davidson, Operating Superintendent on Claymore, a pressure of 400 psi was reached in about 4 hours, whereas the trend record for this line given in the Petrie Report, which was based apparently on readings taken on Claymore, showed that this pressure was reached after about 45 minutes. The pressure records for all 3 gas pipelines are given in Figs 9.1, 9.3 and 9.5 of the Petrie Report and are here reproduced in Figs 7.1-3.
